TECHNICAL REPORT M-321
August 1982

COATINGS AND CATHODIC PROTECTION OF PILING
IN SEAWATER: RESULTS OF 10-YEAR EXPOSURE
AT LACOSTA ISLAND, FL

by
J. Bukowski
A. Kumar

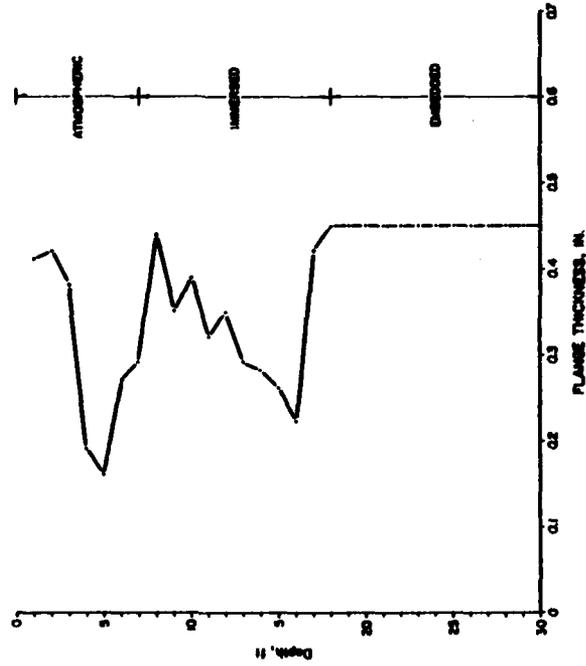
Figure 11. Flange thickness for pile 23B, bare mariner steel (metric conversion factors: 1 in. = 25.4 mm; 1 ft = 0.3048 m).

All piling of bare carbon and mariner steel showed perforation of the web in the atmospheric zone. No significant differences in corrosion rates were noted between the bare carbon and mariner steel after 10-years' exposure at the LaCosta Island test site. The bare steel piles were severely corroded directly above the high tide (splash) zone and just below the low tide area. A zone of severe corrosion also was found at or just below the piling's mud line. The bare steel piling exhibited very little corrosion in the embedded zone.

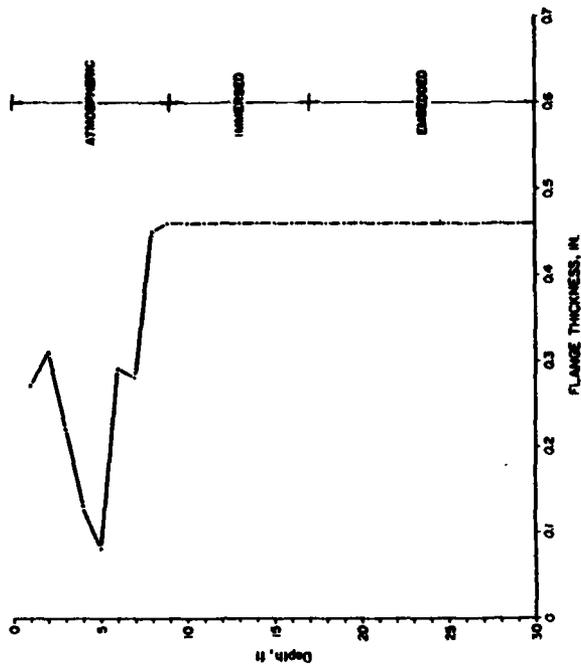
Figure 13. Flange thickness for pile 3B, bare carbon steel with aluminum anodes (metric conversion factors: 1 in. = 25.4 mm; 1 ft = 0.3048 m).

Using sacrificial zinc or aluminum anodes on bare steel piling (Figures 12, 13, and 14) effectively reduced the corrosion rate in the immersed and embedded

zones to less than 0.1 mil (0.003 mm) per year, but had no effect on corrosion in the atmospheric and splash zones.

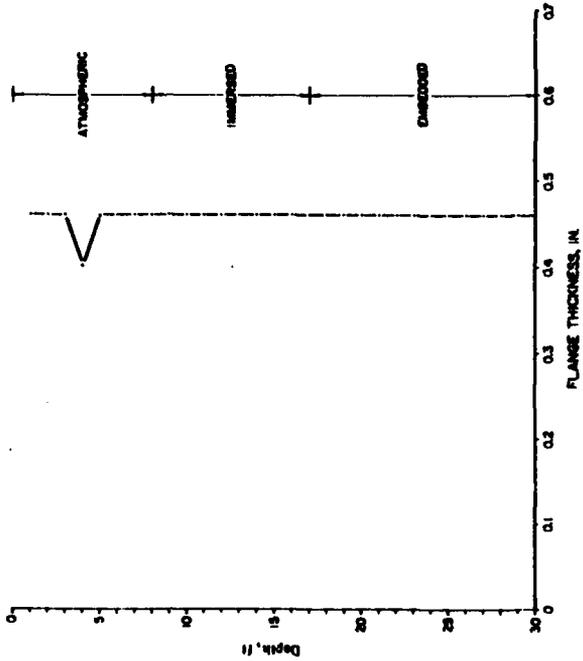
Figure 15. Flange thickness for pile 5B, coal-tar epoxy with zinc anodes (metric conversion factors: 1 in. = 25.4 mm; 1 ft = 0.3048 m).

System 5 was a coal-tar epoxy coating with zinc anodes. The organic coal-tar epoxy coating provided adequate protection to the exposed pile in the atmospheric zone. The immersed zone suffered severe loss of the organic coating, but the steel pile was in excellent condition because of the cathodic protection provided by the sacrificial zinc anodes.

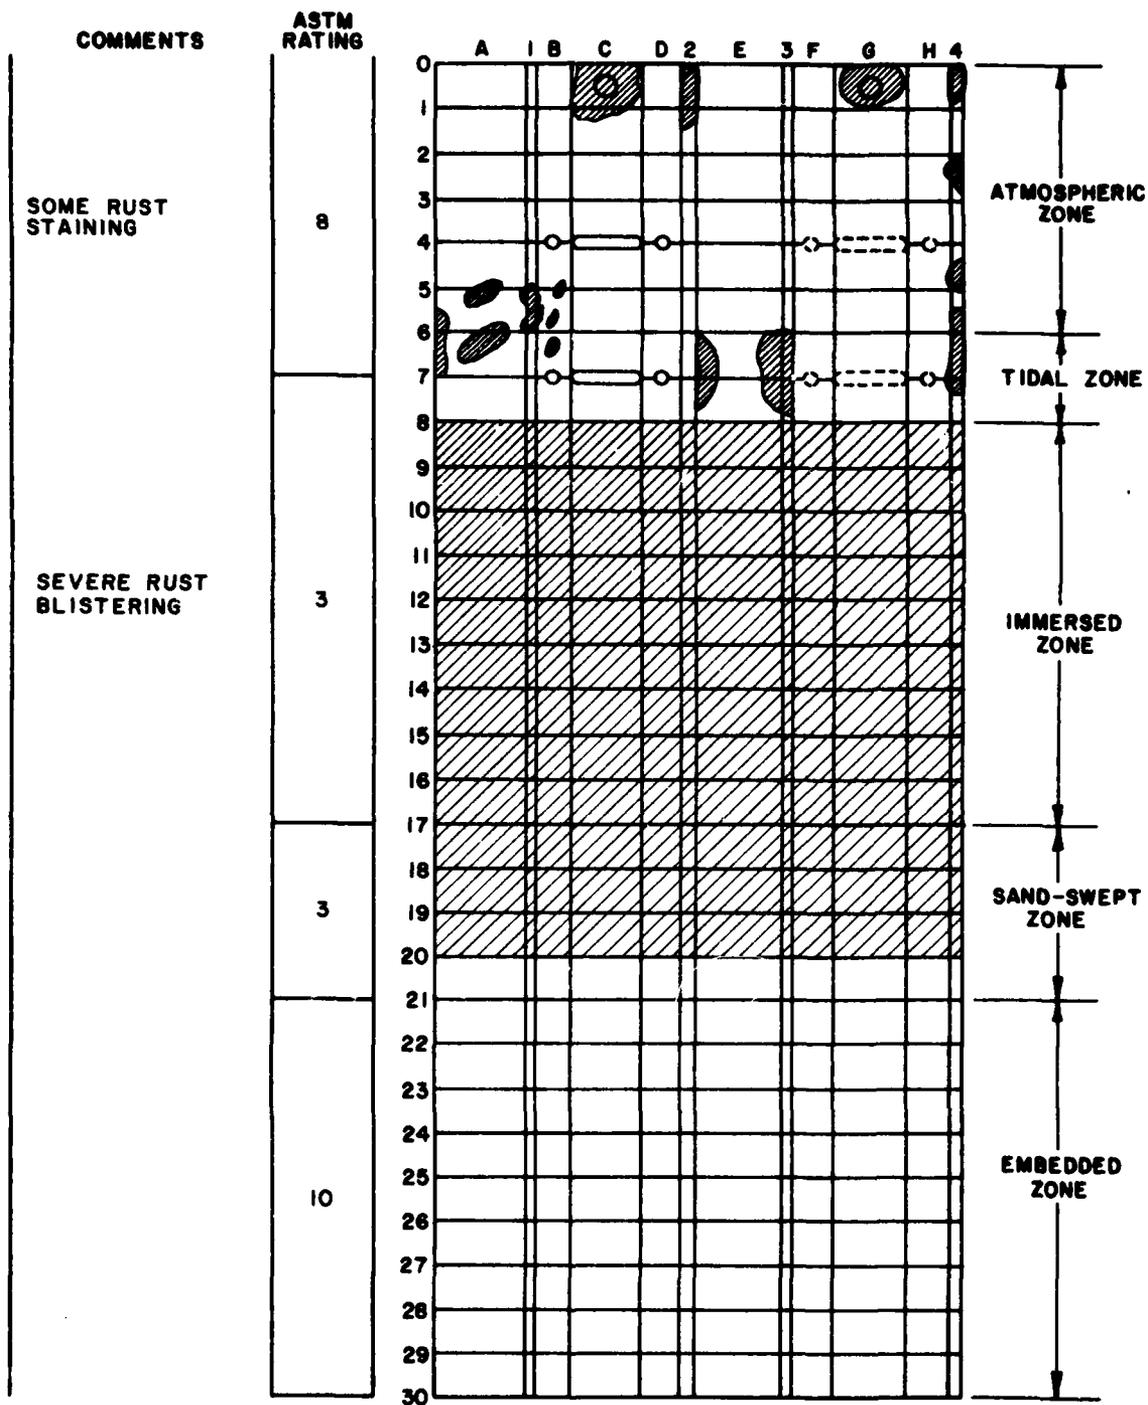
PILE NO. 4A

1. System 4 was a C-200 coal-tar epoxy coating. This system showed some rusting in the atmospheric zone. Rusting and pitting with loss of coating, especially at the flange, was present in the immersed zone edge. In the immersed zone, there was attached marine growth.

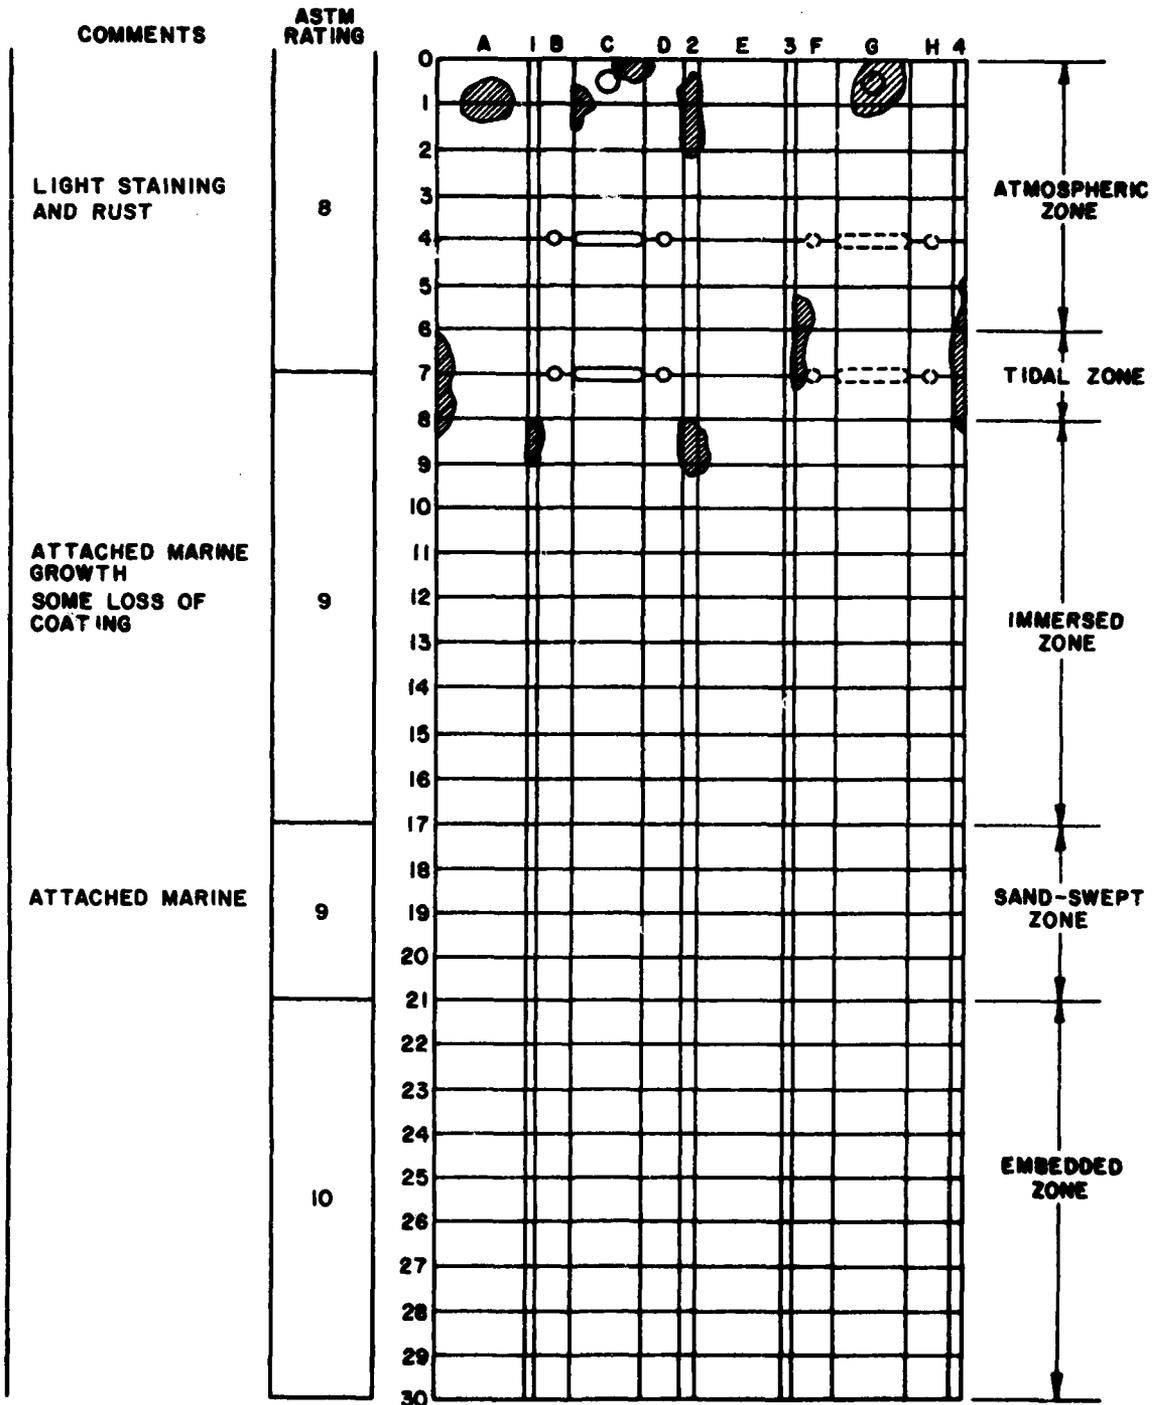
PILE NO. 5A

2. System 5 was a C-200 coal-tar epoxy/polyamide-cured coating with zinc anodes. Light rust and scale were present in atmospheric zone, with some loss of the coating in the immersed zone.

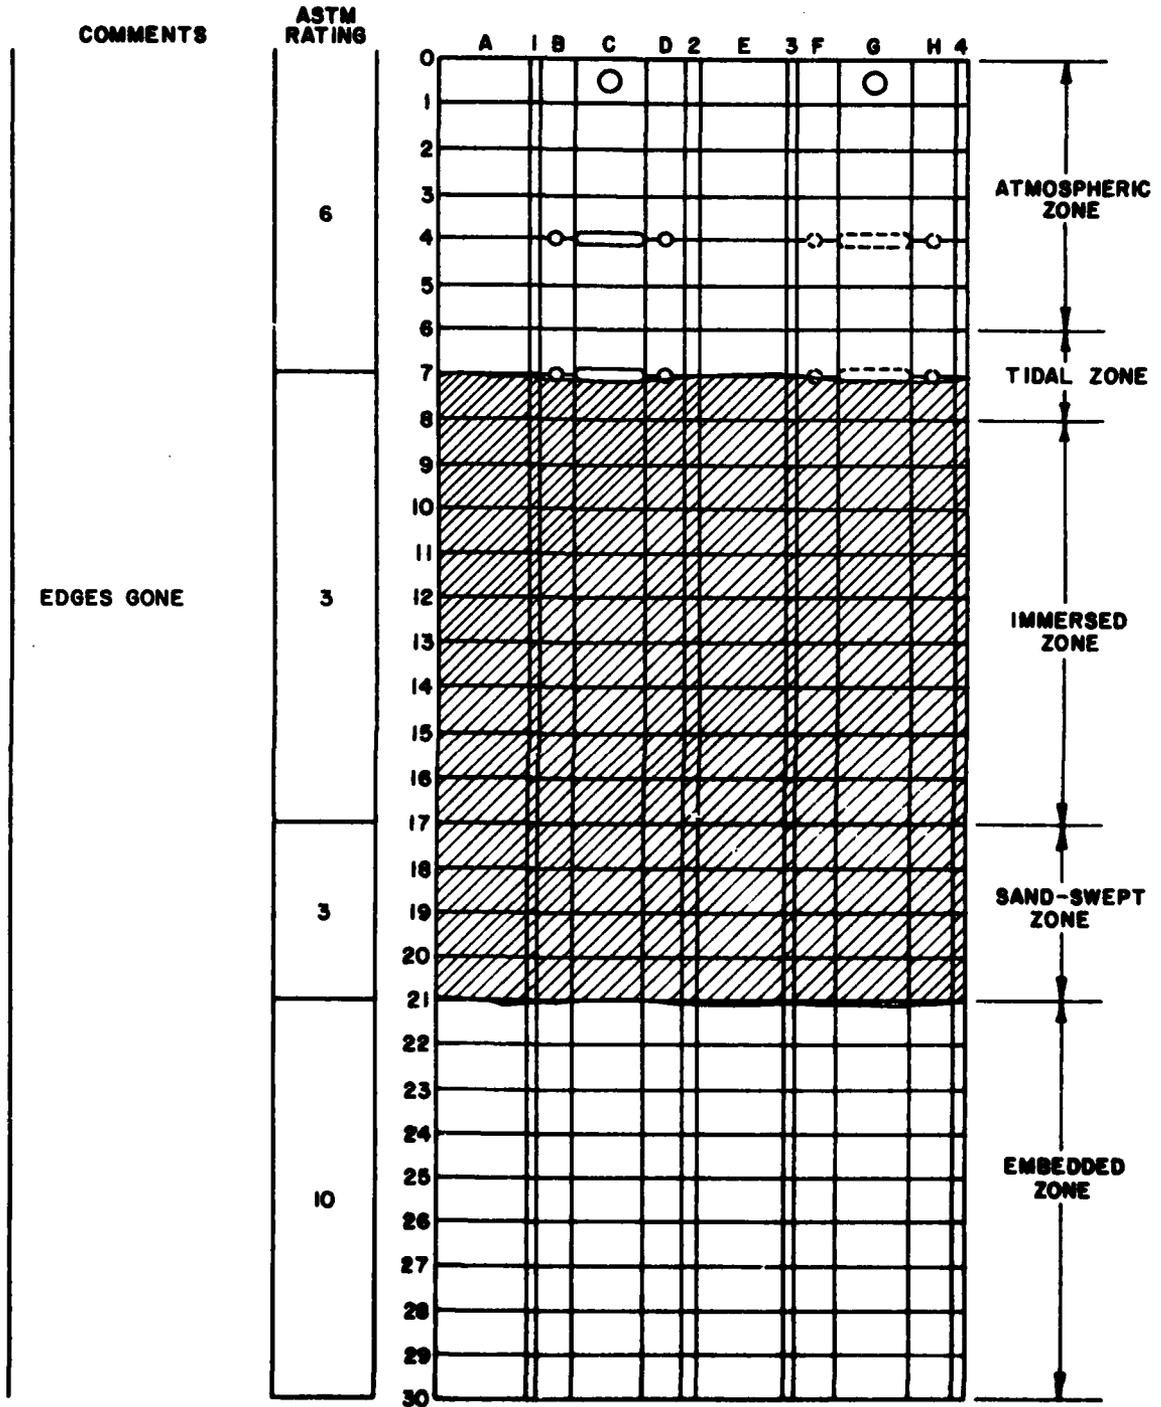
PILE NO. 6A

3. System 6 was a coal-tar epoxy/amine-cured coating. Severe loss of coating in the immersed zone occurred. Some rust and scale were in the atmospheric zone.

EDGES GONE

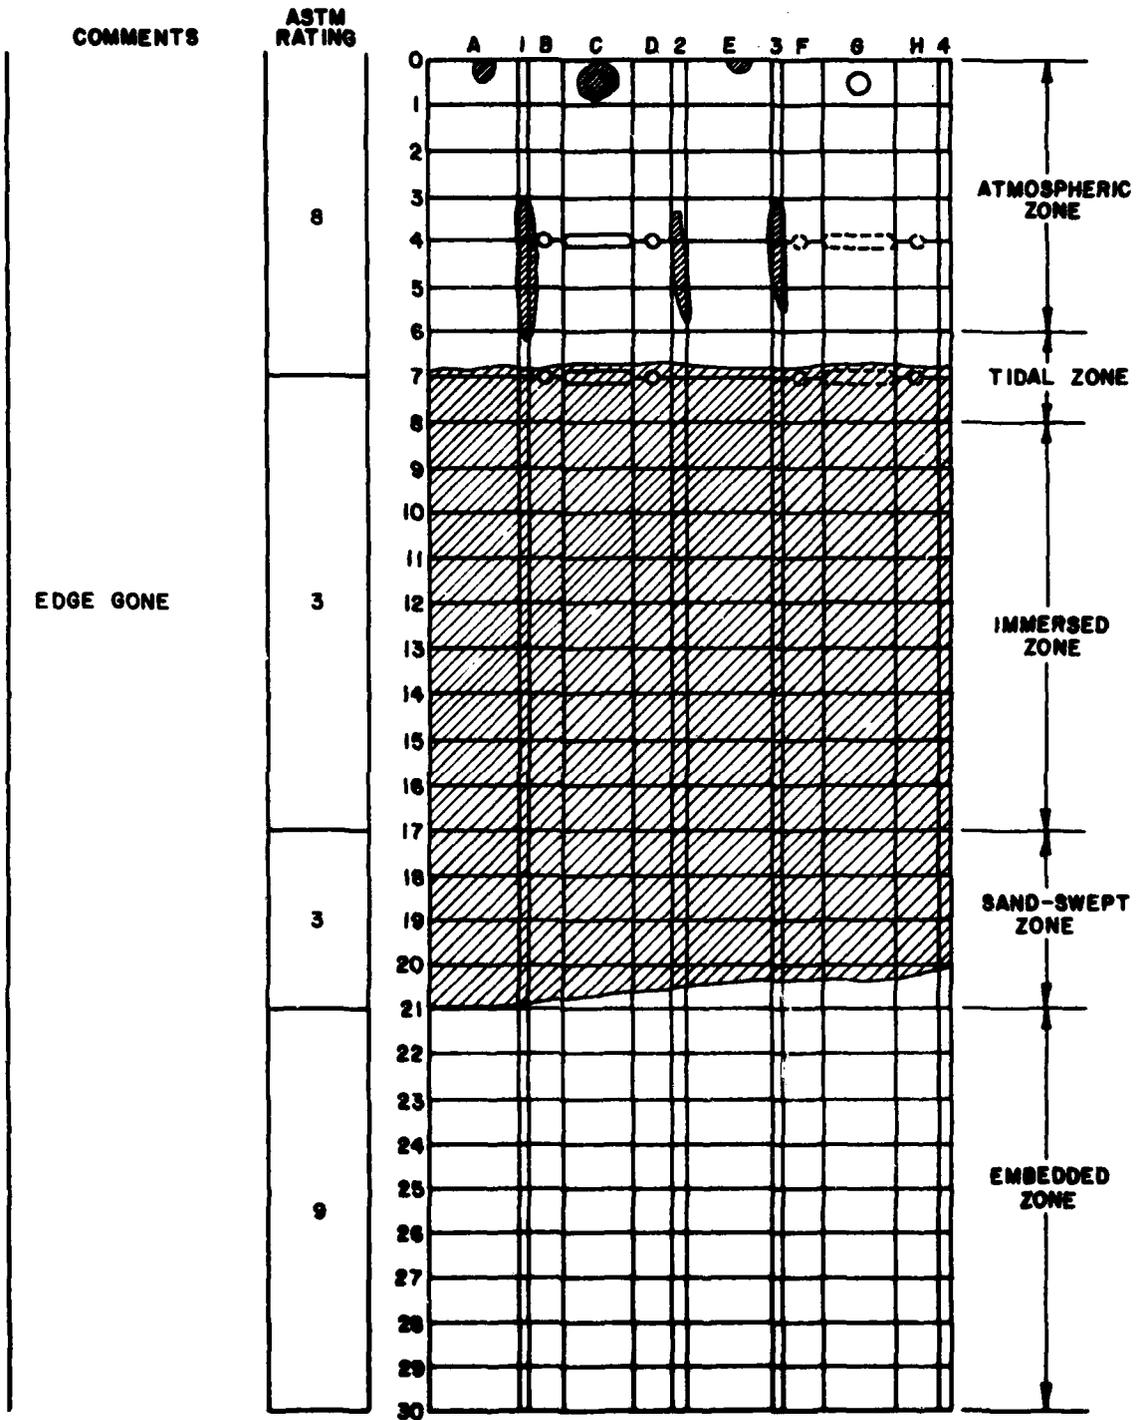
PILE NO. 8A

5. System 8 consisted of an aluminum pigmented epoxy-tar applied over two coats of epoxy tar. There was light rusting along the flange edges in the atmospheric zone. The immersed zone was severely rusted and pitted.

The one system in the metal-filled class—aluminum pigmented epoxy-tar—performed poorly in the immersed and sand-swept zones. This was a three-coat system in which two coats of epoxy-tar electrically insulated, thus preventing the outer coat containing the aluminum pigment from sacrificially protecting the steel pile. The coating was perforated by barnacles, which caused severe pitting in the immersed zone.

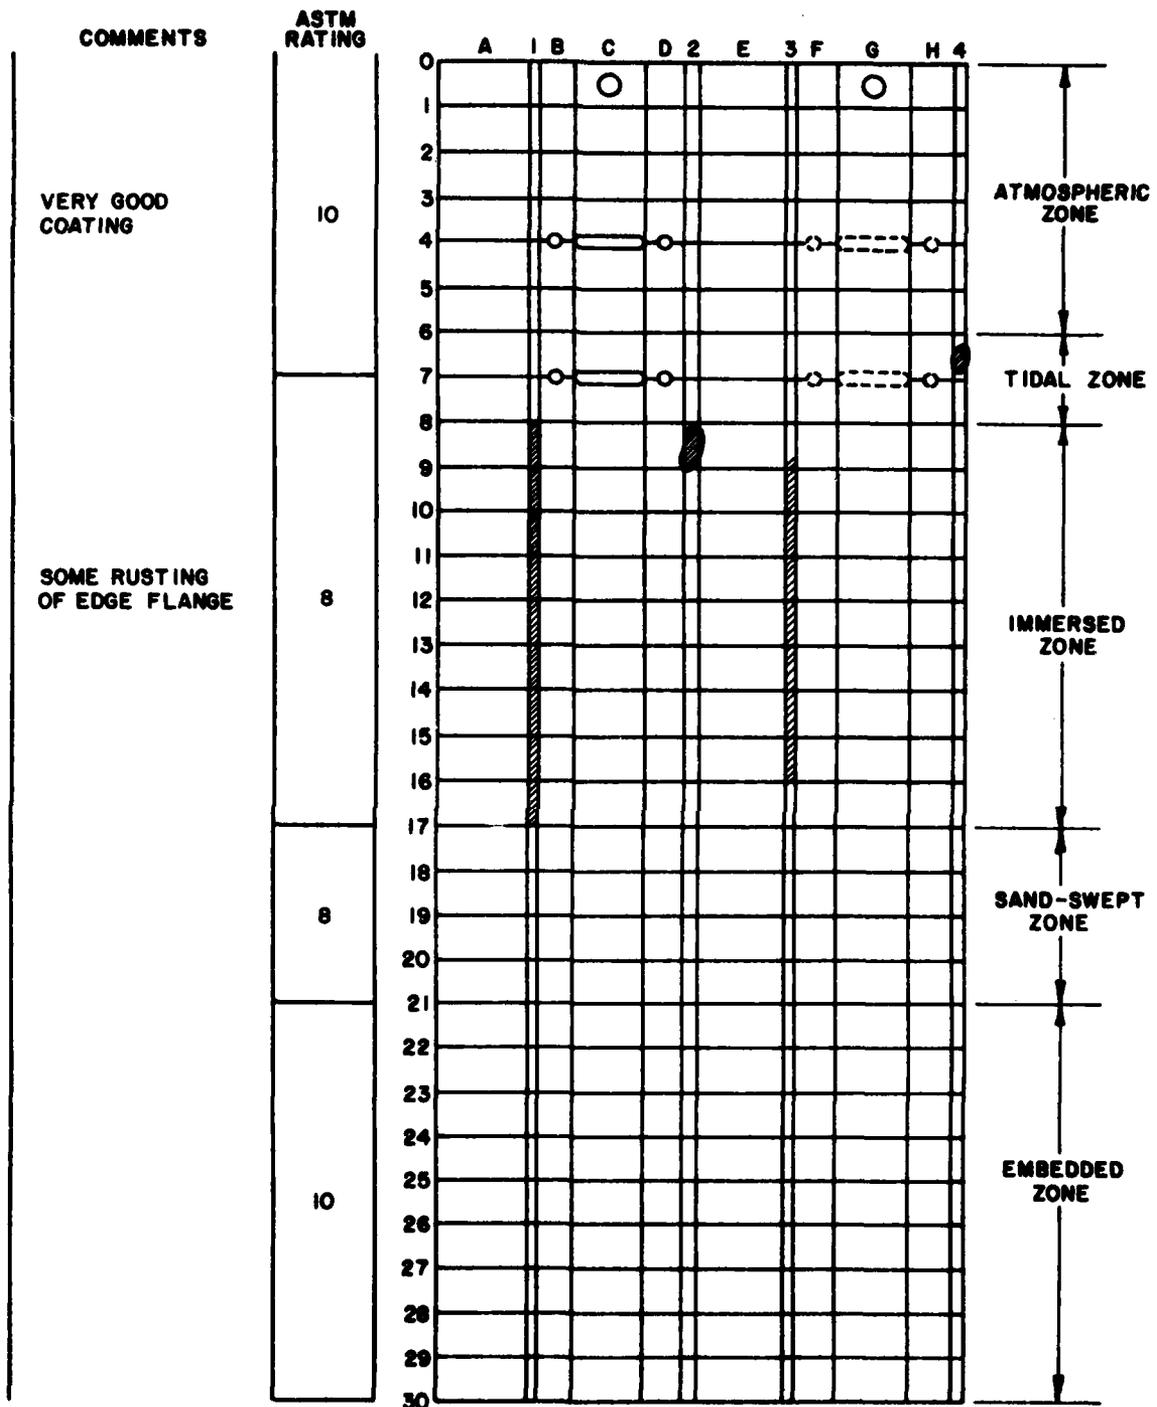
PILE NO. 9A

6. System 9 was an epoxy primer/coal-tar epoxy. This coating system was in excellent condition in the atmospheric zone. There was some rusting of flange edges in the immersed zone.

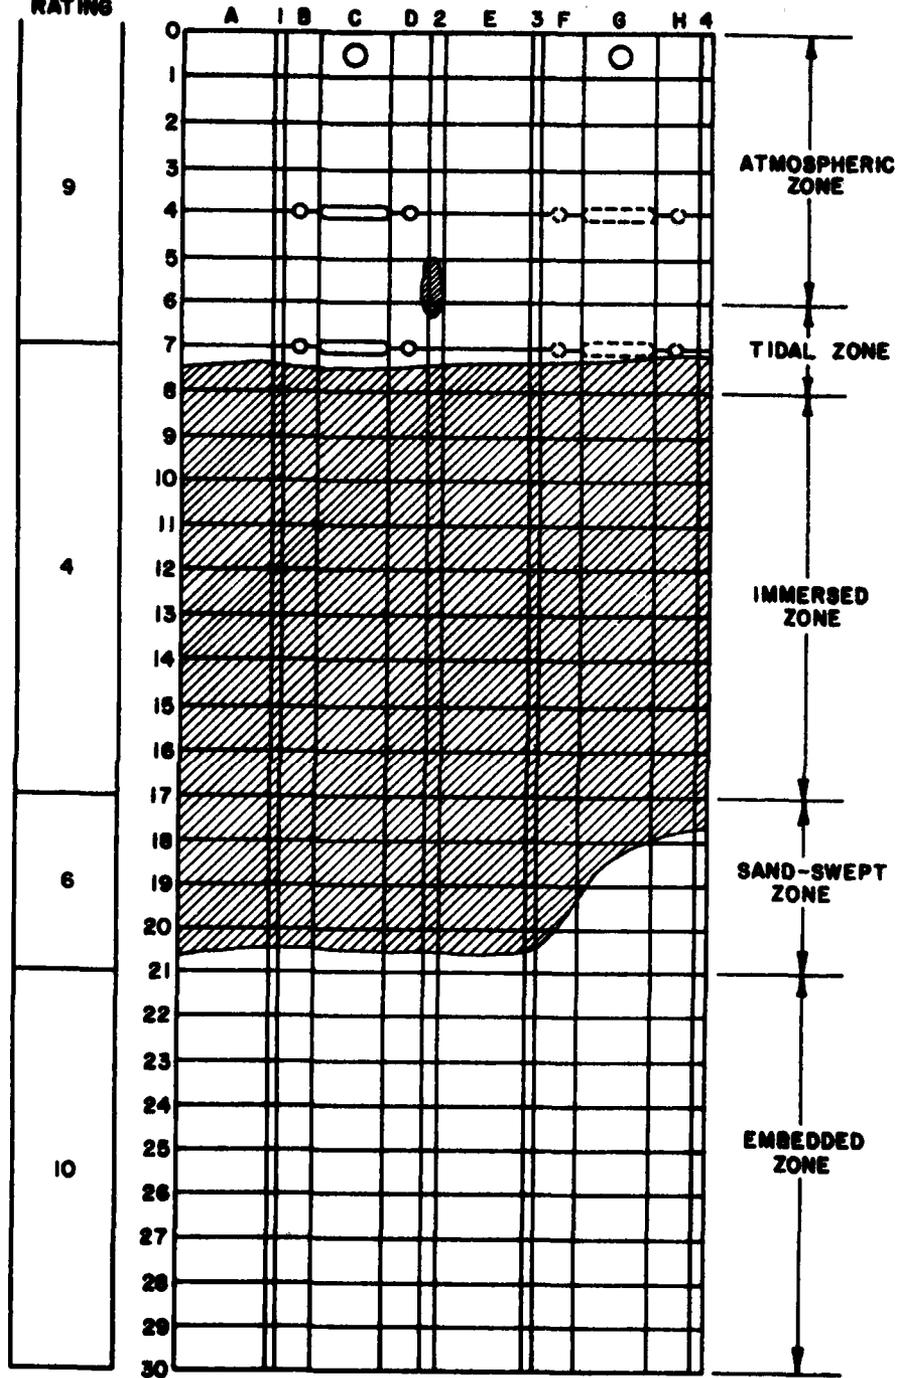
PILE NO. 9B

EDGE IS EXTREMELY CORRODED

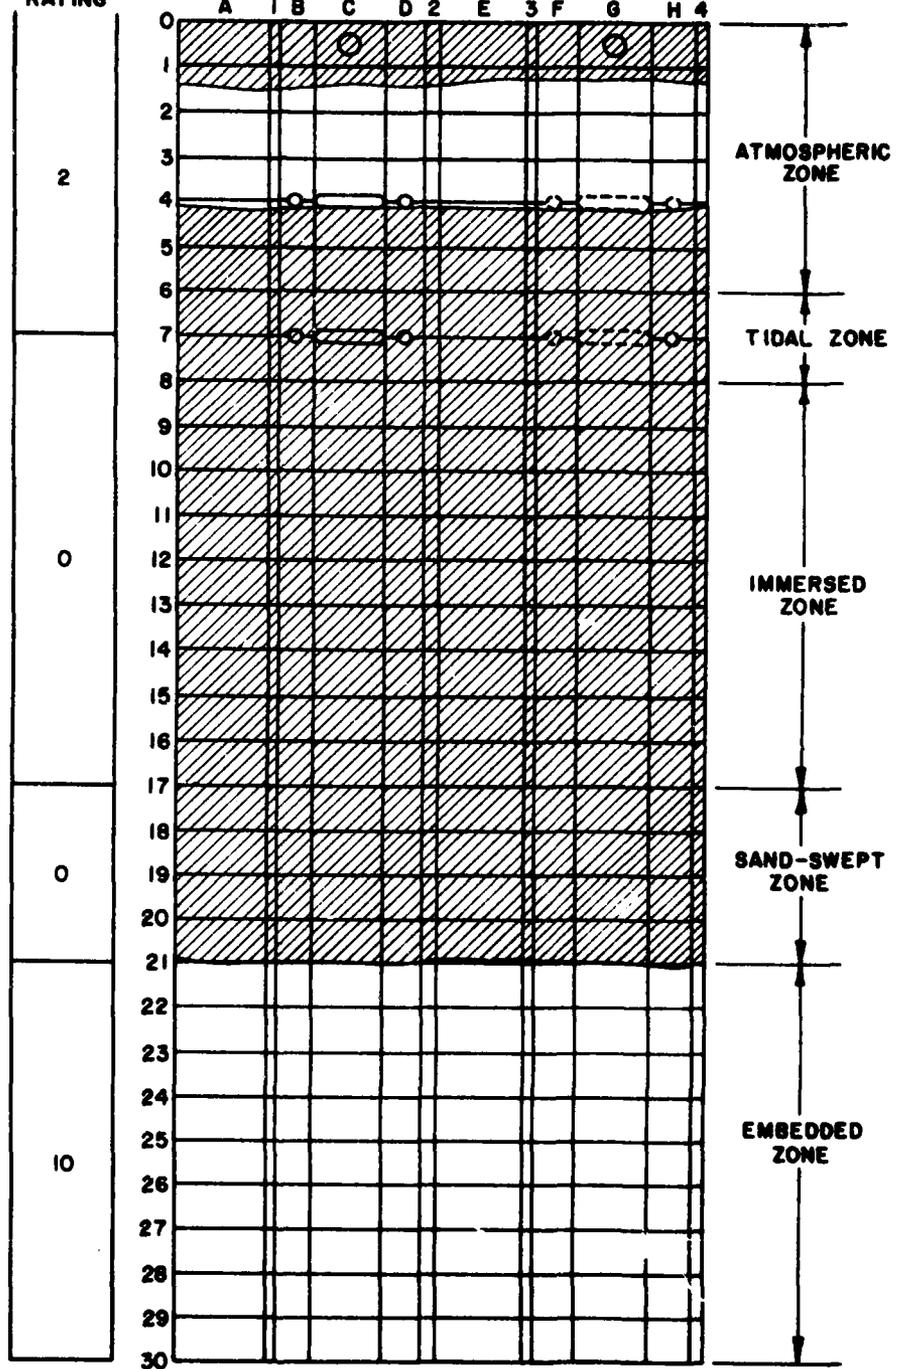
PILE NO. 11A

8. System 11 consisted of a zinc-rich primer with an epoxy topcoat. The coating in the immersed and atmospheric zones was degraded, causing severe rusting and pitting on the steel piling.

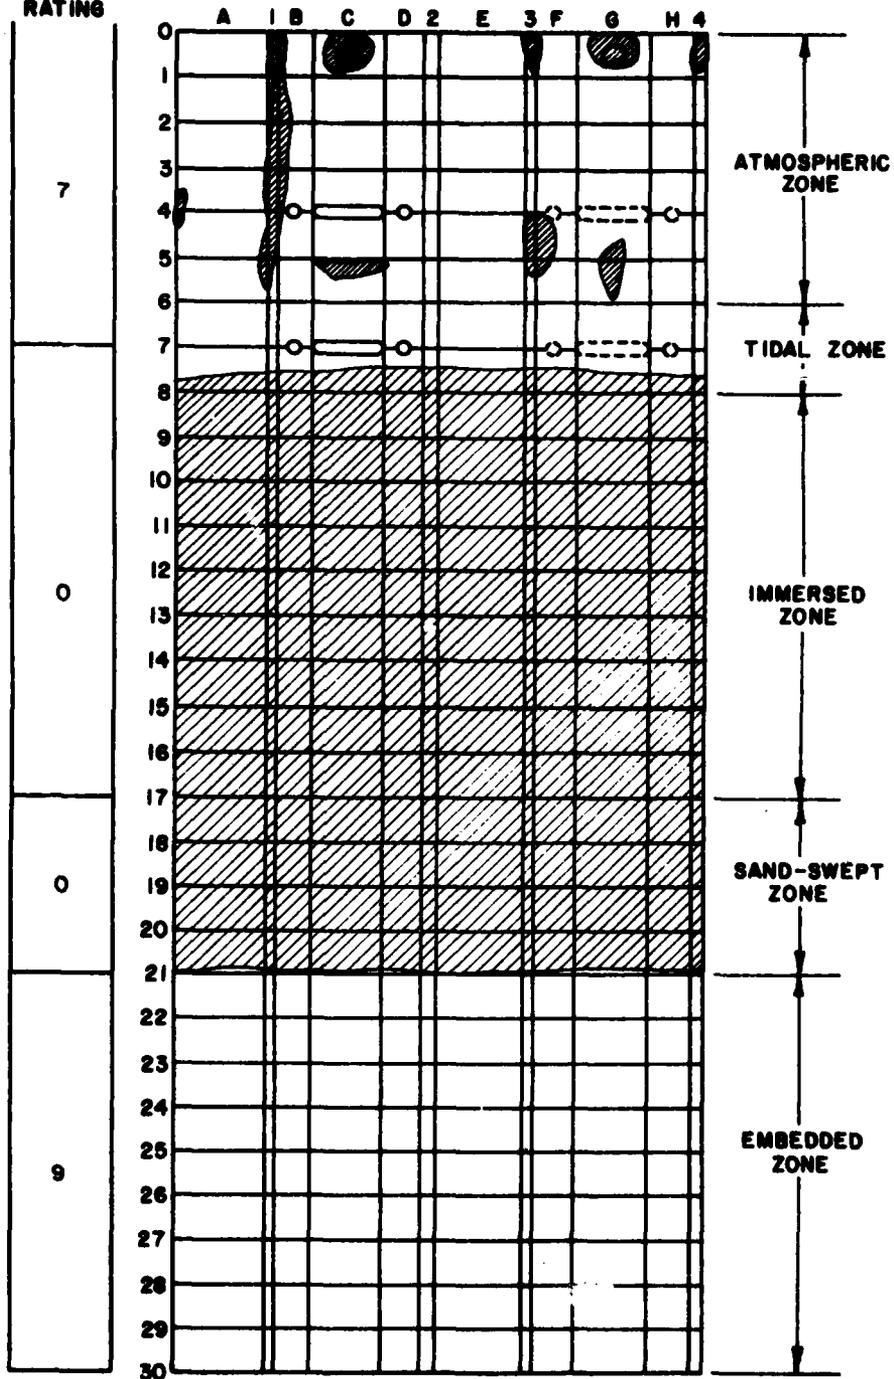
PILE NO. 12A

9. System 12 consisted of a washcoat primer with a saran topcoat. This coating system gave fair protection in the atmospheric zone, where light rust and scale were present, but was completely removed in the immersed zone, where the piling showed rusting and pitting.

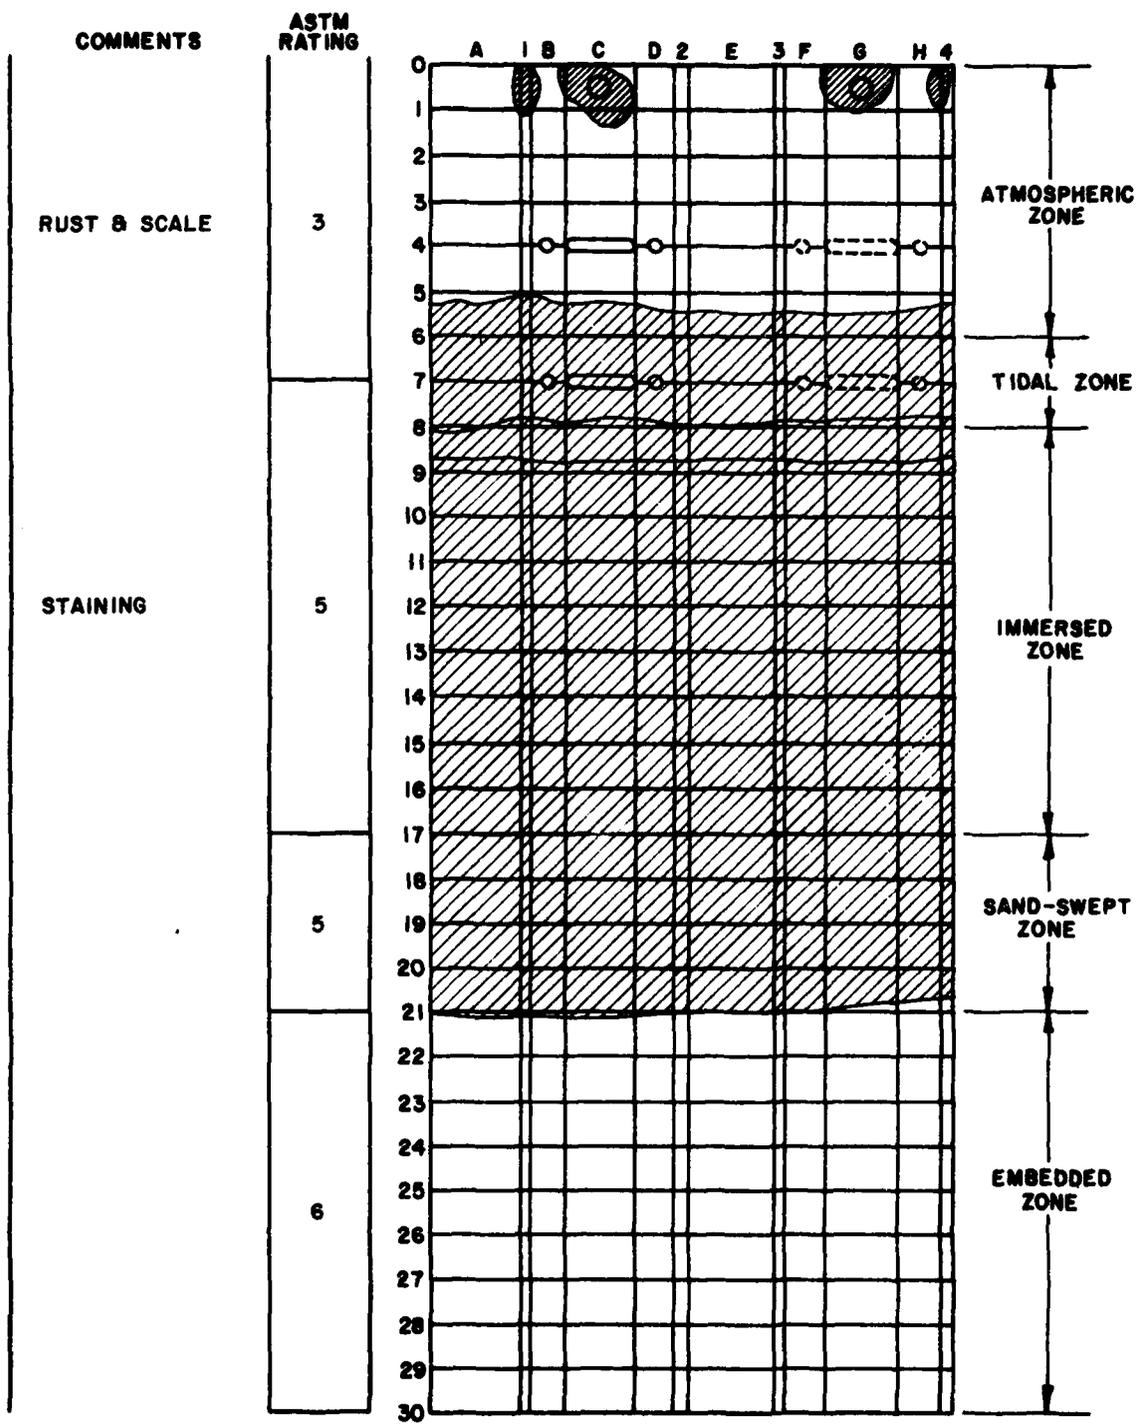
PILE NO. 13A

10. System 13 was a flame-sprayed aluminum coating. Light scale and rusting, present along the length of the piling, was most severe at the splash zone, where there was no sacrificial protection.

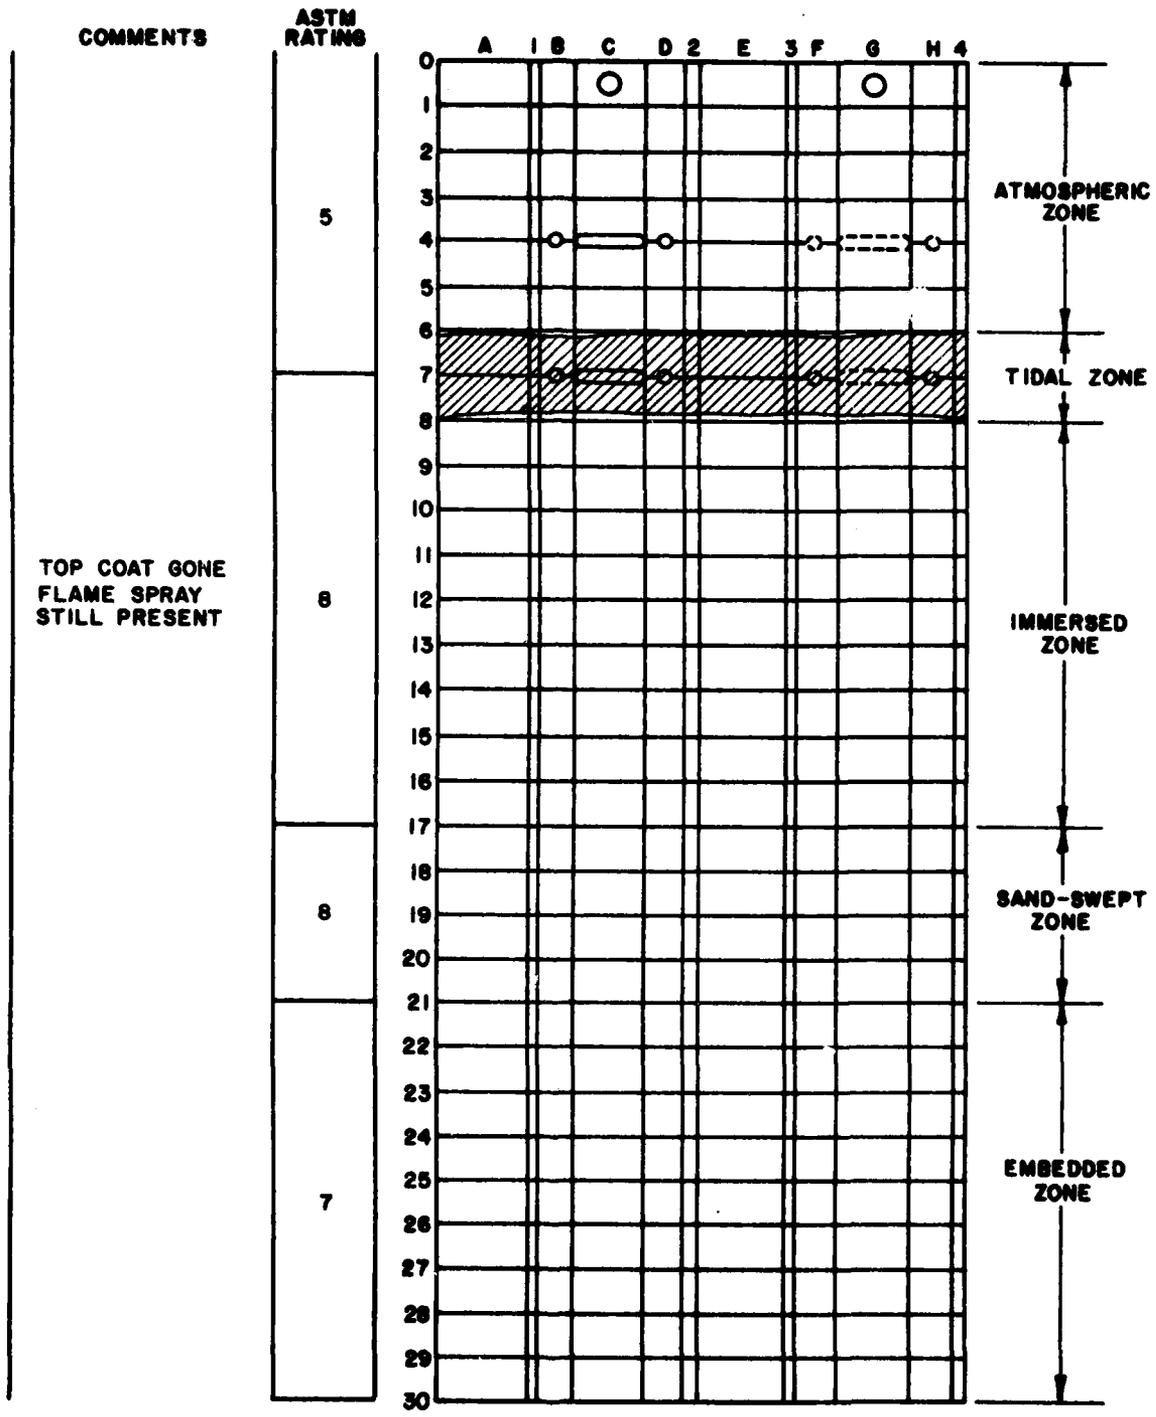
FILE NO. 15A

12. System 15 was a flame-sprayed zinc coating with a saran topcoat. Staining and light rust were present in the atmospheric zone. The saran topcoat was completely gone from the immersed zone, but the flame-sprayed zinc still provided protection.

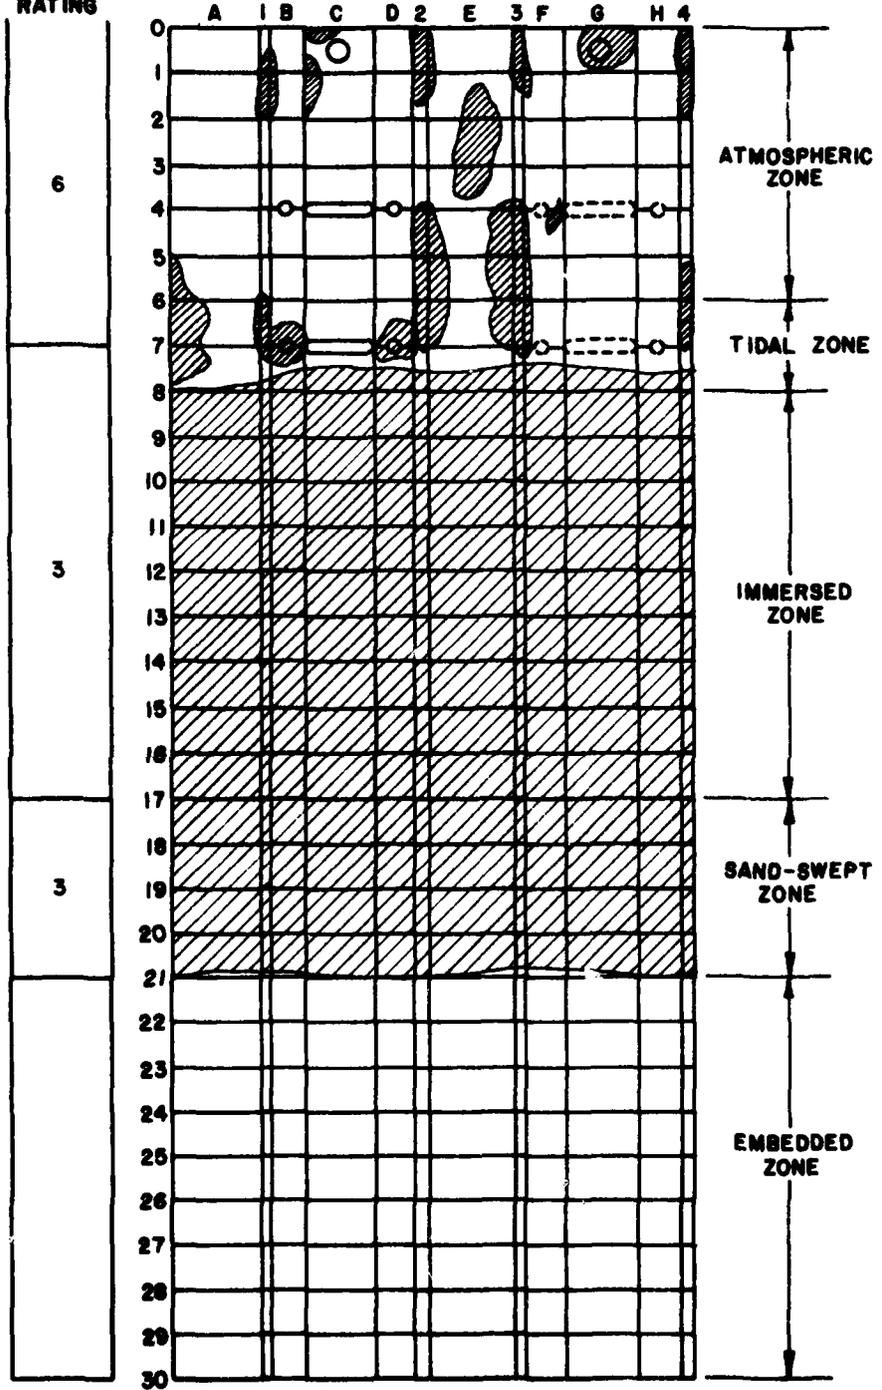
PILE NO. 17B

14. System 17 was a phenolic mastic coating. Light rust and staining were present in the atmospheric zone. Pitting on steel flange edges and severe loss of coating had occurred in the immersed zone.

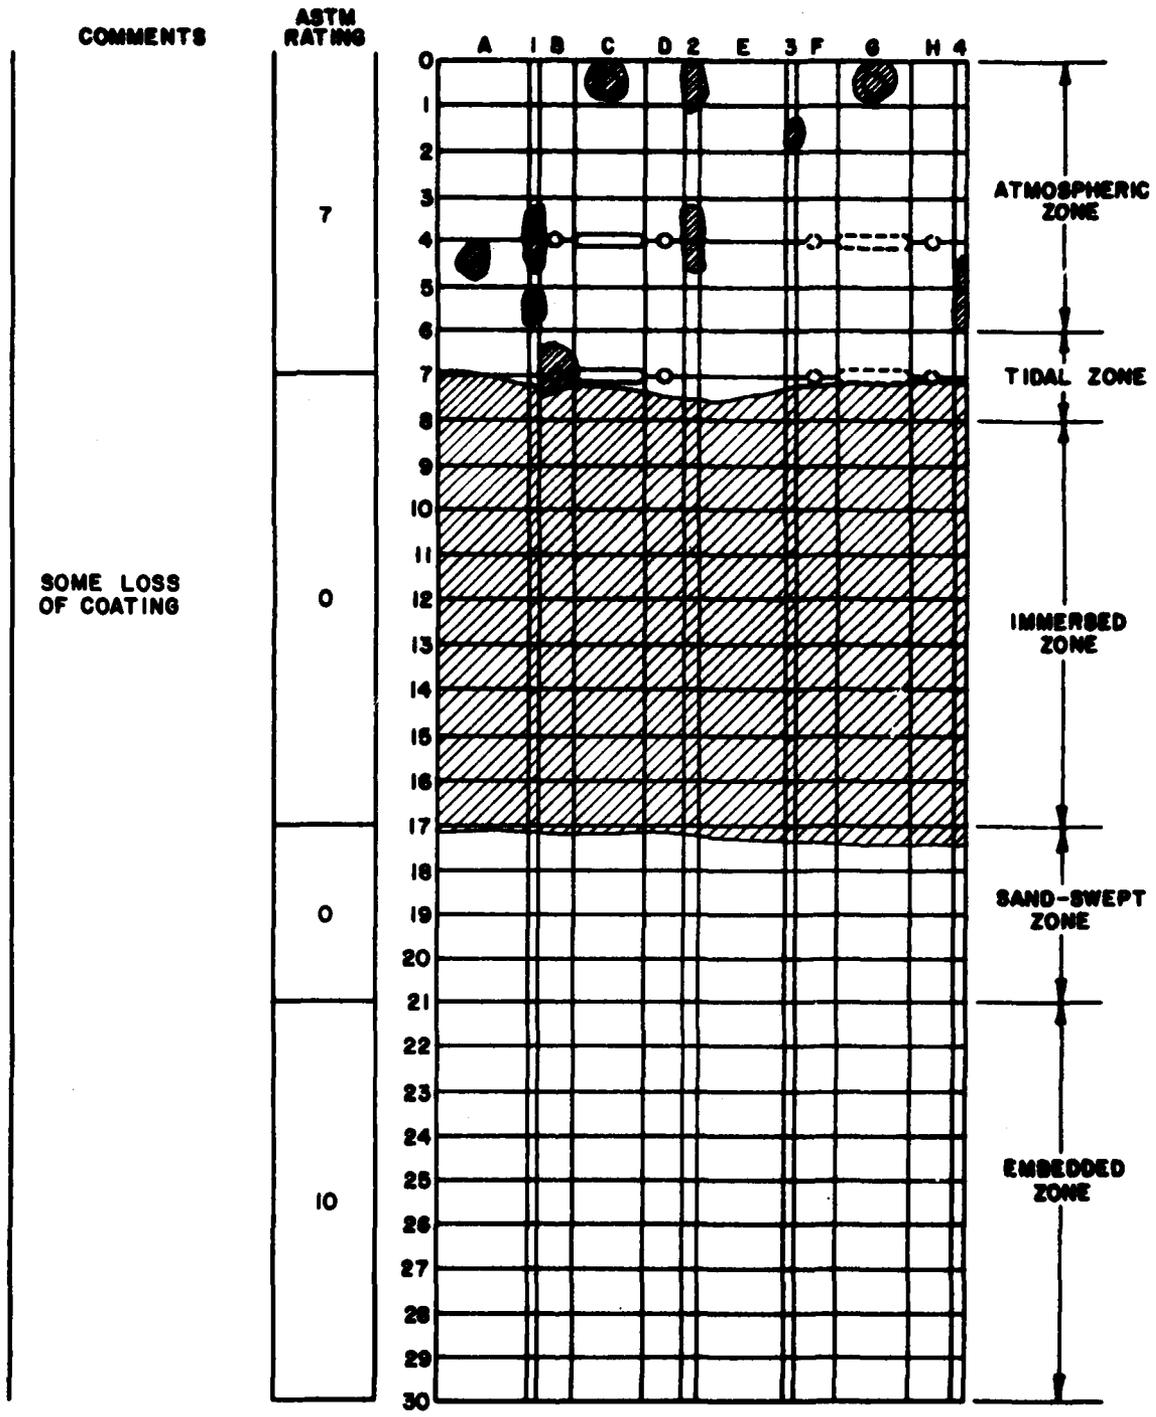
PILE NO. 19A

16. System 19 was a coal-tar epoxy with organic zinc-rich primer. Some rust and blistering were present in the atmospheric zone. In the immersed zone, there was severe loss of coating, with rusting and pitting.

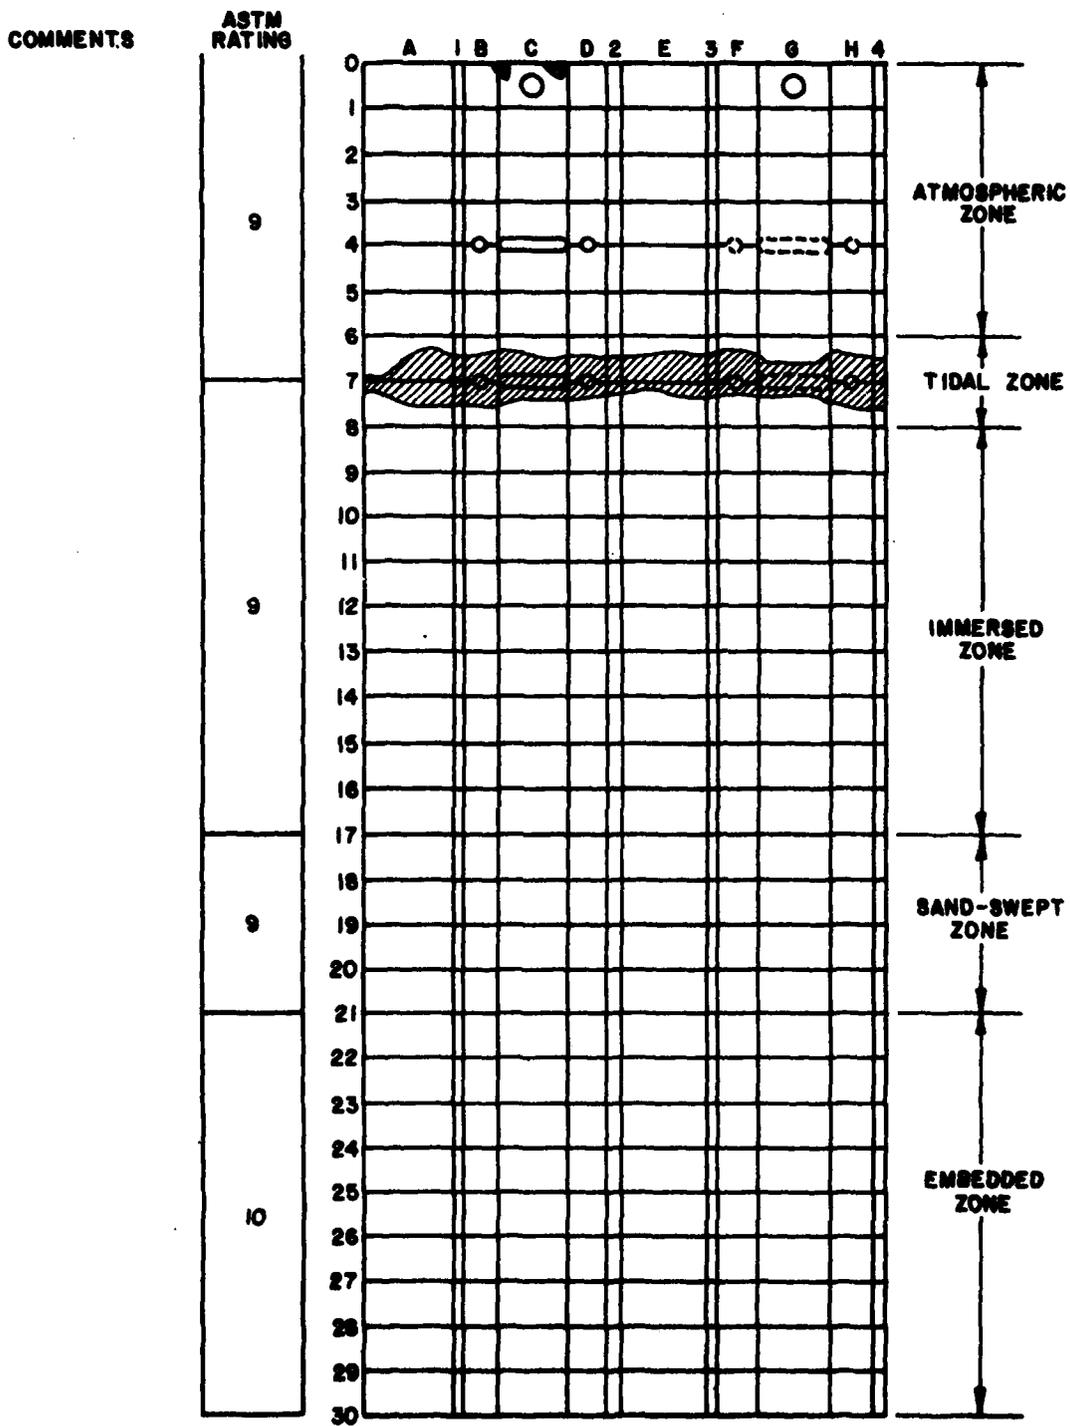
PILE NO. 20A

17. System 20 consisted of an inorganic zinc-rich primer with a high-build epoxy-polyamide. Light rust and scale were present in the tidal zone. Overall, the coating's condition was very good.
